Contract #: 04-0120F4Cty: SF/ALA Rte: 80 PM: 13.2/13.9File #: 1.28**WELDING INSPECTION REPORT****Resident Engineer:**Siegenthaler, Peter**Address:** 333 Burma Road**City:** Oakland, CA 94607**Report No:** WIR-022956**Date Inspected:** 21-Apr-2011**Project Name:** SAS Superstructure**OSM Arrival Time:** 700**Prime Contractor:** American Bridge/Fluor Enterprises, a JV**OSM Departure Time:** 1730**Contractor:** American Bridge/Fluor Enterprises, a JV**Location:** Job Site

**Summary of Items Observed:**

## WELDING INSPECTION REPORT

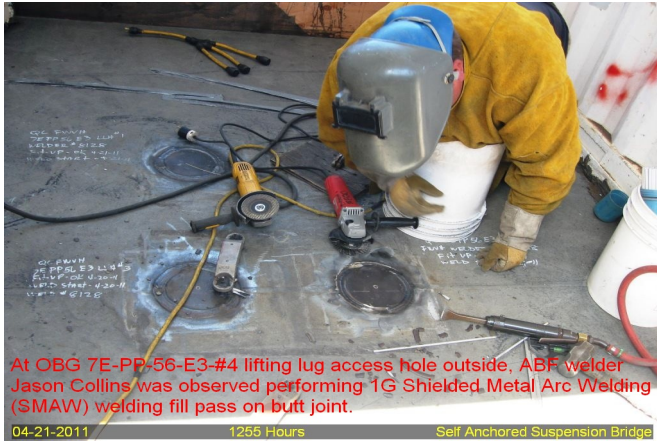
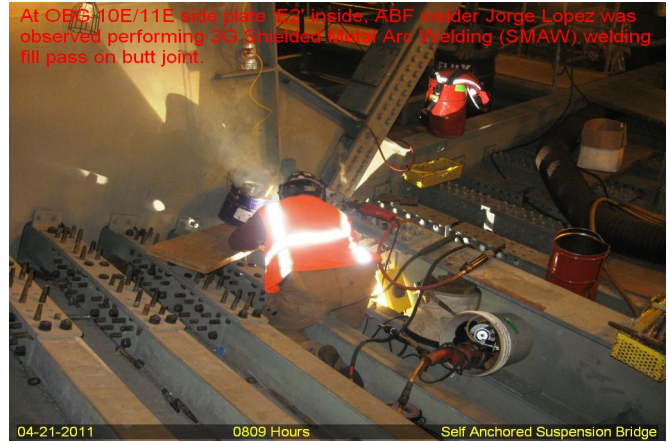
At OBG 10E/11E side plate 'E2' (4677mm to 5277mm) inside, QA randomly observed ABF/JV qualified welder Jorge Lopez continuing to perform fill pass to cover pass welding on the Complete Joint Penetration (CJP) splice butt joint where the track mounted Bug-o FCAW welder nozzle holder has limited access. The welder was observed manually welding in the 3G (vertical) position utilizing a Shielded Metal Arc Welding (SMAW) with 1/8" diameter E7018H4R electrode and implementing Caltrans approved Welding Procedure Specification (WPS) ABF-WPS-D15-1040B. The joint being welded has a single V-groove butt joint with steel backing bar. During welding, ABF Quality Control (QC) John Pagliero was noted monitoring the welding parameters of the welder. At the end of the shift, cover pass SMAW welding at location mentioned above was completed. After the completion of the side plate just mentioned, the welder also welded 120mm long on the bottom plate 'D2' and joined the transition weld to the side plate 'E2'. This was also completed during the shift and the welder started flush grinding the weld cover reinforcement until the end of the shift.

At OBG 10E/11E side plate 'C1' (0mm to 1000mm) inside, QA randomly observed ABF/JV qualified welder Fred Kaddu continuing to perform root pass to fill pass welding on the Complete Joint Penetration (CJP) splice butt joint where the track mounted Bug-o FCAW welder nozzle holder has limited access. The welder was observed manually welding in the 3G (vertical) position utilizing a Shielded Metal Arc Welding (SMAW) with 1/8" diameter E7018H4R electrode and implementing Caltrans approved Welding Procedure Specification (WPS)
